**ASTM E 90-09:** Laboratory Measurement of Airborne Sound Transmission of **Building Partitions and Elements**

Test Number: OL10-0943

Project Sound Transmission Loss Testing

**Test Date Specimen**  September 29, 2010 Fixed Window

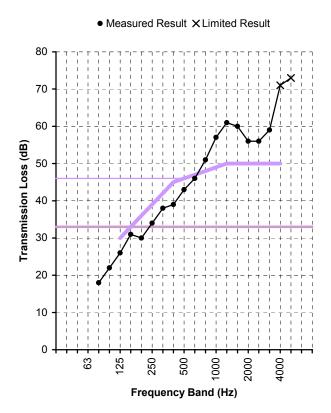
Single Number Rating **STC =** 46 **OITC = 33**

Freq.	TL	Def.			
(Hz)	(dB)	(dB)			
80	18				
100	22				
125	26	4			
160	31	2			
200	30	6			
250	34	5			
315	38	4			
400	39	6			
500	43	3			
630	46	1			
800	51	-			
1000	57	-			
1250	61				
1600	60	-			
2000	56	-			
2500	56				
3150	59	-			
4000	71*	-			
5000	73*				
Total De	Total Deficiencies 31				
* Estimate of laws a limit

\* Estimate of lower limit

Freq. Band (Hz)	Specimen T.L. (dB)	95% Conf. (dB)	Flanking Limit (dB)	STC Defic. (dB)	R <sub>w</sub> Defic. (dB)	OITC Level (dBA)
25						
31.5	22.7 †		40			
40	17.6 ‡		47			
50	21.8 ‡		43			
63	22.6 ‡		43			
80	17.8	±1.63	42			63
100	21.7	±1.15	45		4.3	61
125	25.9	±0.95	46	4	3.1	59
160	30.9	±1.27	52	2	1.1	54
200	29.6	±1.24	53	6	5.4	56
250	33.7	±0.65	56	5	4.3	52
315	38.0	±0.65	60	4	3.0	49
400	39.0	±0.62	61	6	5.0	49
500	42.7	±0.40	65	3	2.3	47
630	45.6	±0.50	66	1	0.4	43
800	50.8 ‡	±0.40	69	-	-	38
1000	56.9 ‡	±0.25	70	-	-	32
1250	61.1 ‡	±0.25	72	-	-	29
1600	60.2 ‡	±0.32	72	-	-	29
2000	55.8	±0.44	74	-	-	33
2500	56.4	±0.35	79	-	-	32
3150	59.2	±0.31	83	-	-	27
4000	71.1 *†	±0.49		-		14
5000	72.5 *†	±0.35				
6300	70.3 *†					
8000	69.6 *†					
10000						
Total deficiencies below STC contour (dB) 31						
STC contour [ASTM E413] 46						
Total deficiencies below R <sub>w</sub> contour (dB) 28.9						
R <sub>w</sub> contour	[ISO 717/1]				45
